Drainage Used to Control Movements of a Large Rock Slide in Canada

by John C. Sharp, Consultant/Principal,
Golder Associates,
Maidenhead, Berkshire, United Kingdom

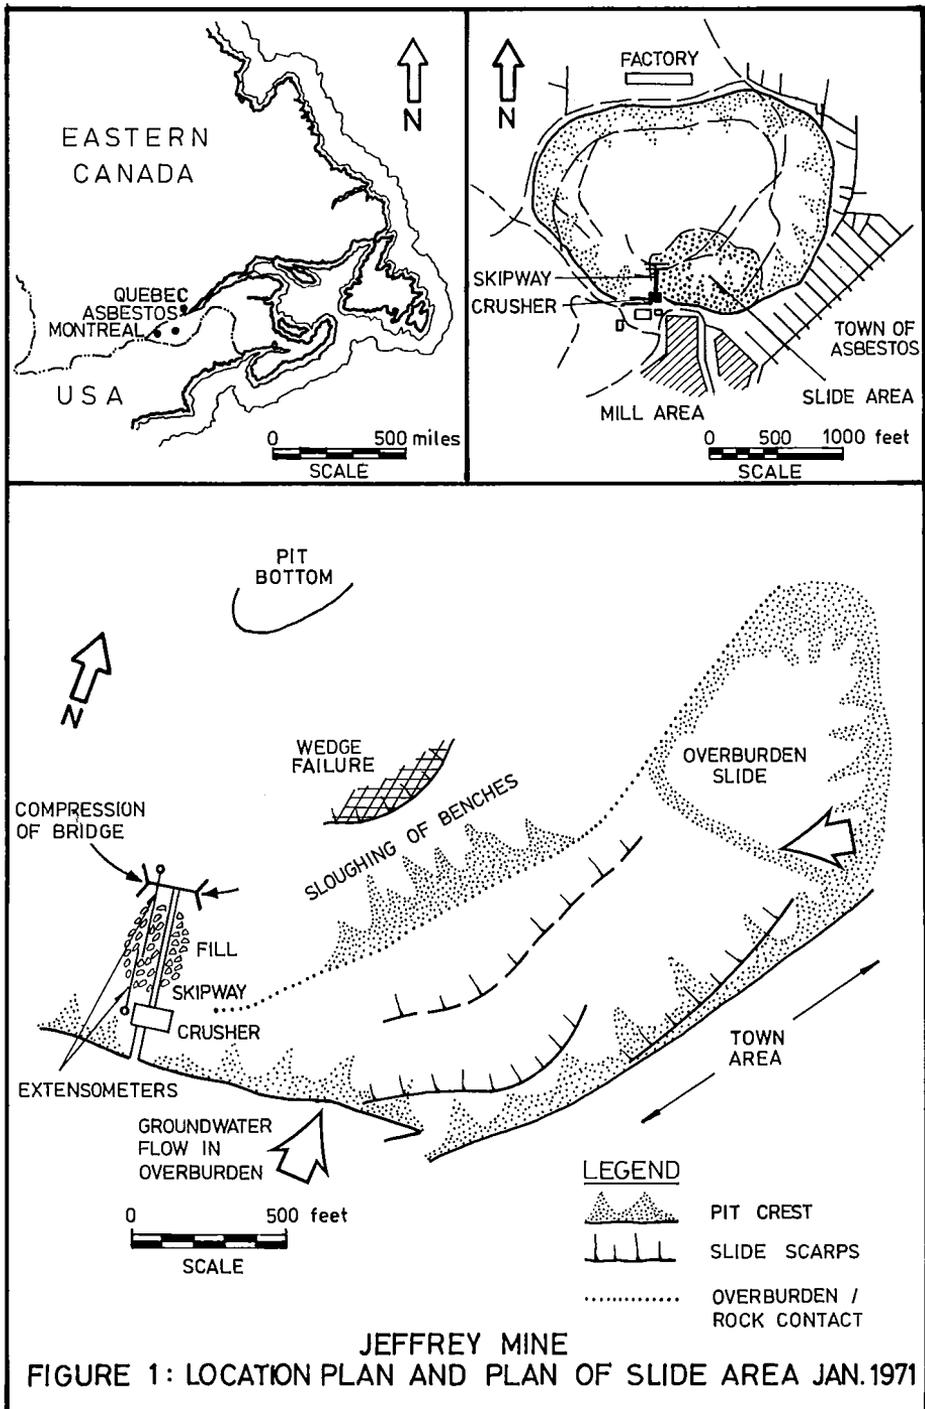
The open pit, approximately 1,000 ft. deep, is immediately west of the town of Asbestos. On the south side of the pit are located the major crushing and milling facilities (see general location plan; Figure 1).

A significant gravel layer carries water from the south and discharges from the lower overburden slopes to the east of the skipway (see Figure 1). This water source, along with surface precipitation, appears to form the main source of groundwater for the south east corner rock slopes.

Between 1965 and 1970 the benches forming the upper rock slopes had failed due to rock deterioration within the relatively weak shear zone material (see Figures 1, 3).

During 1970, a gradual extension of the skipway rails was observed (see Figure 1). The skipway rails had been

Because of the critical role of the skipway installation in the mining operation, extensometers were installed from the crest of the slope and from the ore pass bridge level to check the depth of movement (see Figure 1). The instruments became operational at the end of 1970.

Groundwater sources are illustrated generally in Figure 1. The phreatic surface within the slope profile is shown in Figure 3. The shape of the surface illustrates the high degree of recharge from the overburden slopes as well as the relatively impermeable nature of the major shear zone.

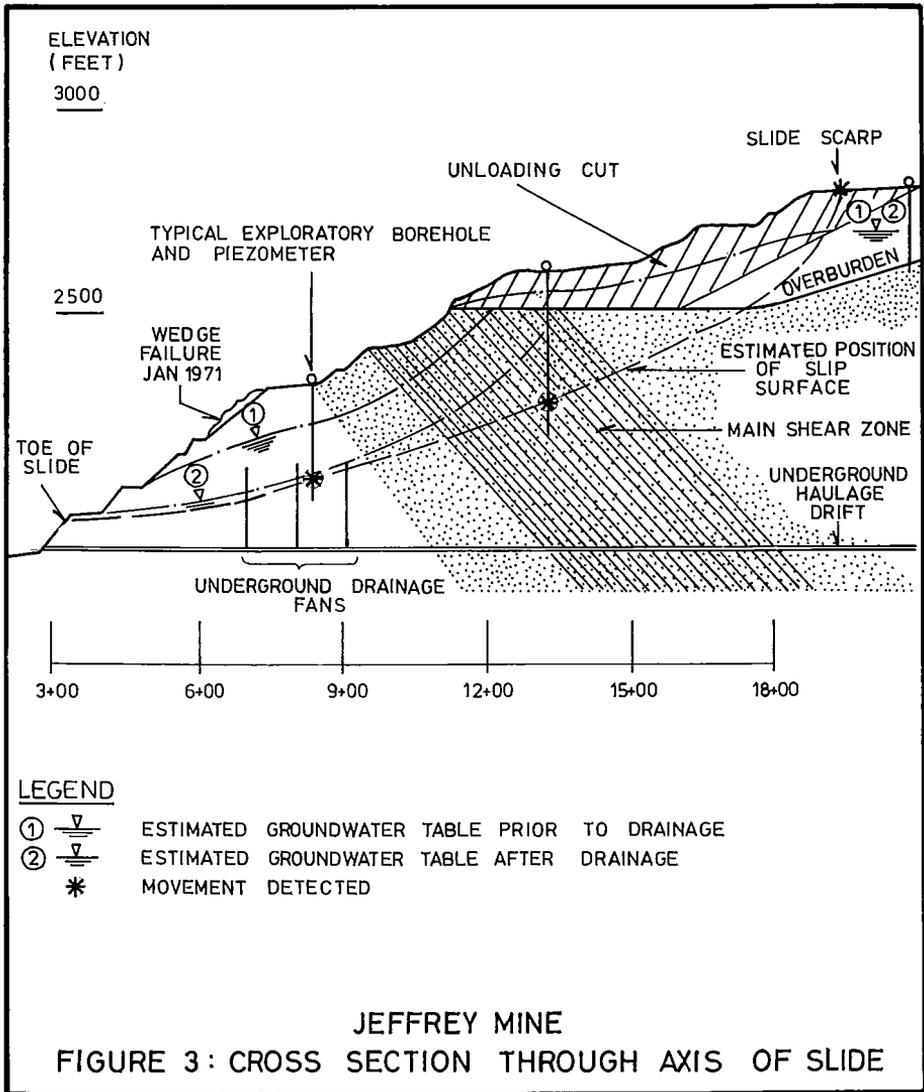
This geology is shown generally in Figure 3. A major shear zone dips into the slope and outcrops on the upper part of the slope. The shear zone consists of highly fractured serpentinised material up to 500 ft. in width. The underlying peridotite is also traversed by other, lesser, generally sub-parallel, shear zones. Fracturing is somewhat irregular and typical of the host rock of an asbestos ore body. Fractures are often infilled with asbestos or brucite fibres and characteristically have a low shear strength.

In January 1971, a localised wedge failure between the 2,220 ft and 2,320 ft elevations occurred below the main haul road in relatively competent rock (see Figures 1, 3). The failure was controlled by localised jointing although some extension of fractures may have occurred due to small, overall movements of the slope.

- (1) Mining operations at the toe of the slope. The excavation of material in this area reduced the volume of the competent lower rock buttress (See Figure 3) to a critical state where it was no longer able to support the overlying shear material and overburden. The build-up of shear stress through the buttress probably led to the extension of unfavourable oriented shallow dipping joints to form a continuous shear surface at the base of the buttress. This was accompanied by significant internal shearing along fractures oriented roughly parallel to the main shear zone as well as a general break-up and dilation of the more competent rock.
- (2) Adverse groundwater conditions as detailed below.

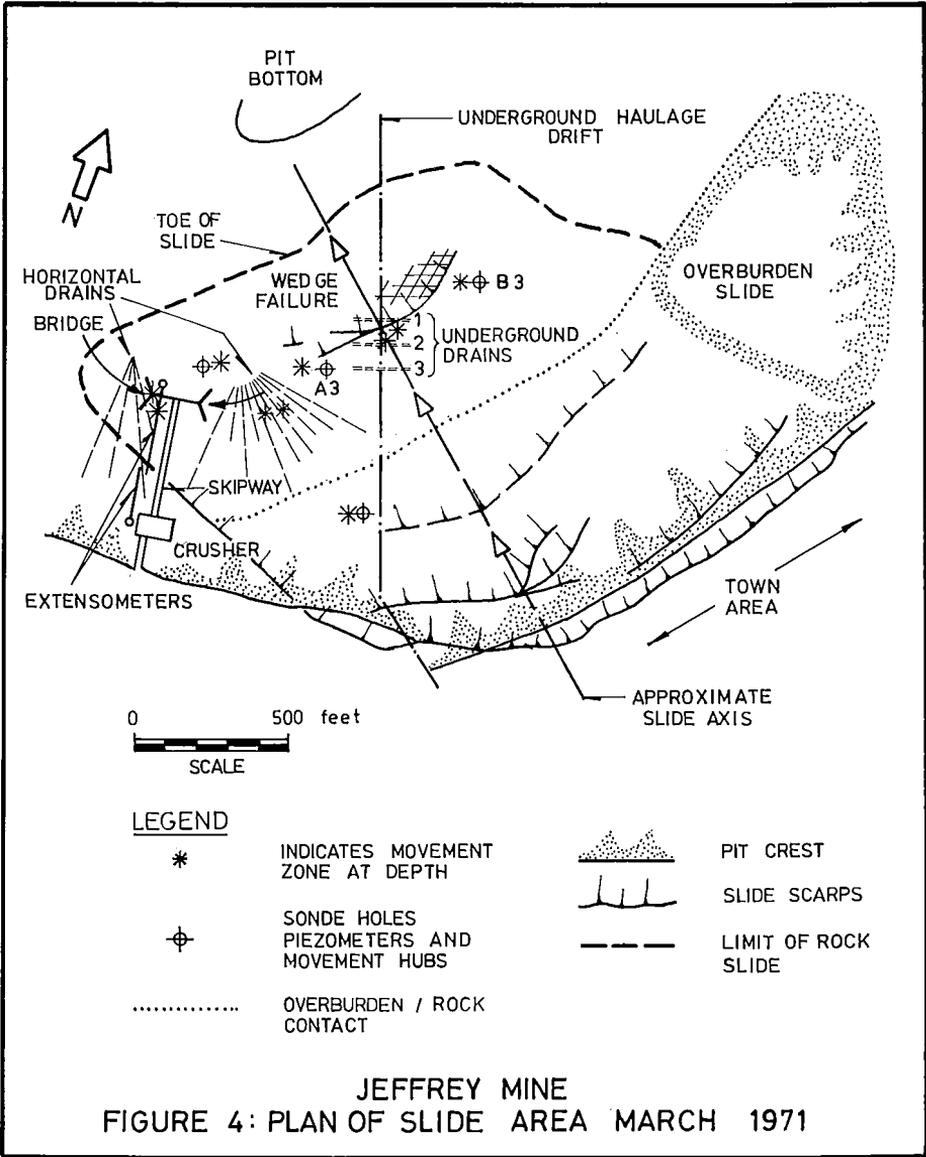
Measurements on the surface and in boreholes (inclino-meter measurements or casing deformation observations using sondes) indicated movement of the entire slope some 700 ft. in height, 2,000 ft. in width and at depths up to 250 ft. (see Figures 3, 4). Approximately 20 m tons of material were contained within the slide zone. The observations

- (1) drainage of the overburden materials to minimise recharge into the underlying rock.
- (2) horizontal drains from the skipway bridge area into rock (see Figure 4).
- (3) drain holes drilled upwards from the underground haulage drift into the base of the slide (see Figures 3, 4).

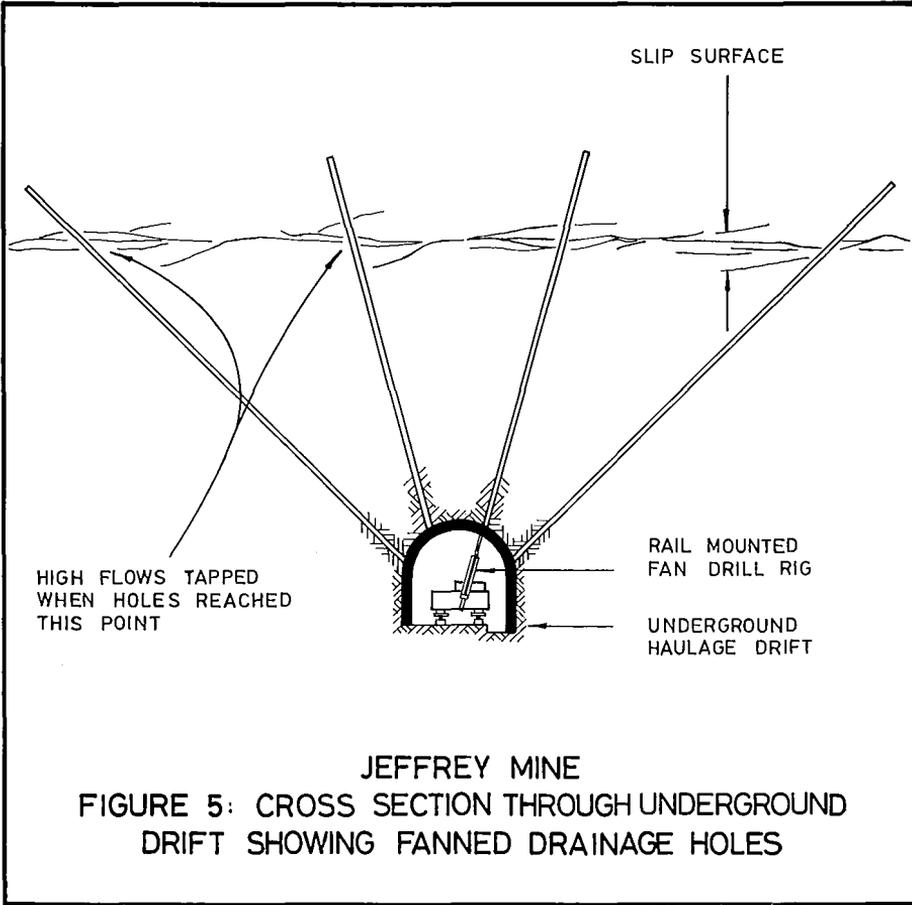
Based on the success of the drillholes from surface, it was decided to rehabilitate the underground haulage drift and drill into the lower central slide area. Twelve drainage holes were drilled from a rail mounted rig so as to intersect the slide zone as illustrated in Figure 5. As expected a highly permeable zone, several feet thick was intersected and water under pressure flowed initially at some 200 gpm. This flow decreased after several months to about 20 gpm after pressures had dissipated across the base of the slide. The relative permeability of the intact and failed material was demonstrated by the lack of influence

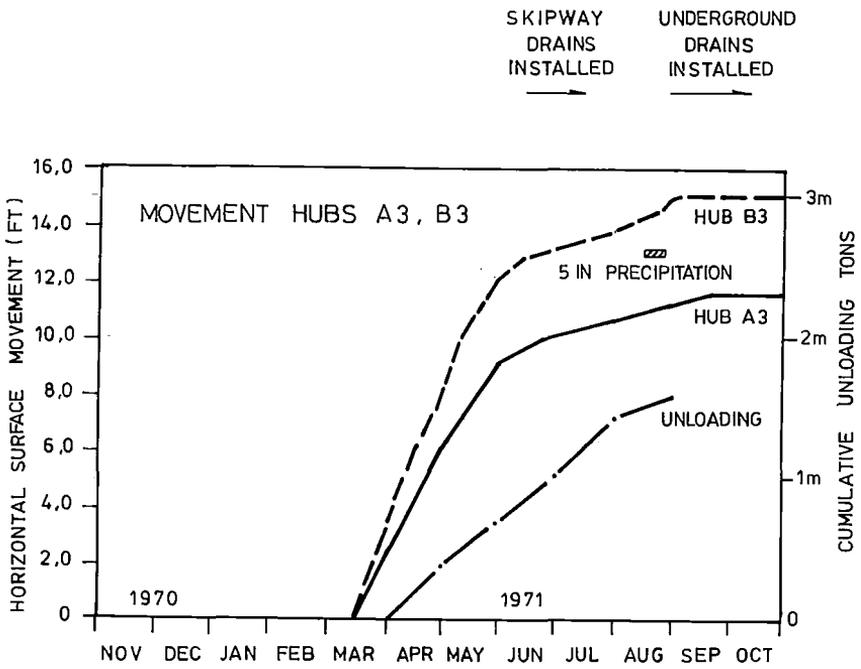
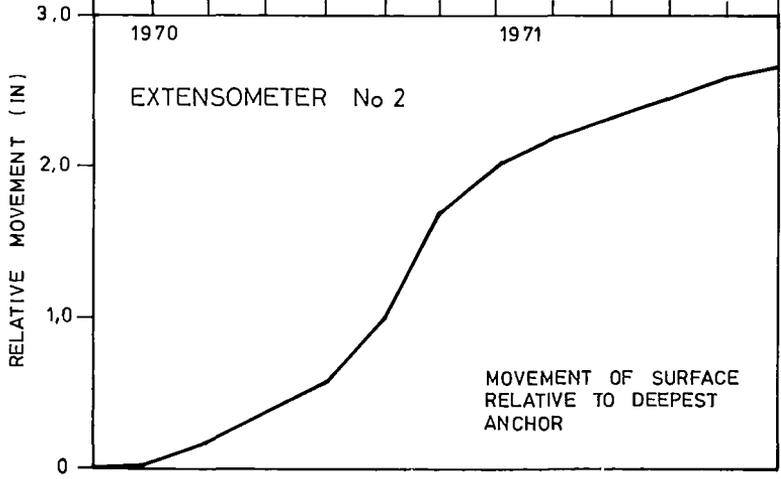
JEFFREY MINE
 FIGURE 7: SURFACE MOVEMENT AND EXTENSOMETER DATA

Surface monitoring of the slide area showed a significant reduction in movement rates following completion of the initial drainage measures and the overburden stripping (see Figure 7).

A similar movement trend was observed from the lower skipway extensometer as illustrated in Figure 7.

The sensitivity of stability to minor changes in groundwater conditions is indicated by a significant increase in movement rates in early August 1971 following approximately 5 in. of rainfall within 24 hours (see Figure 7).
