## **CONSTRUCTION OF A CONCRETE PLUG IN THE SOUTH DEEP'S MAIN SHAFT TO SEAL OFF A MAJOR WATER INTERSECTION**

**M F Wells**

BSc.Eng[Min], MSAIMM, AMMoSA  
Business Unit Manager, Cementation Mining

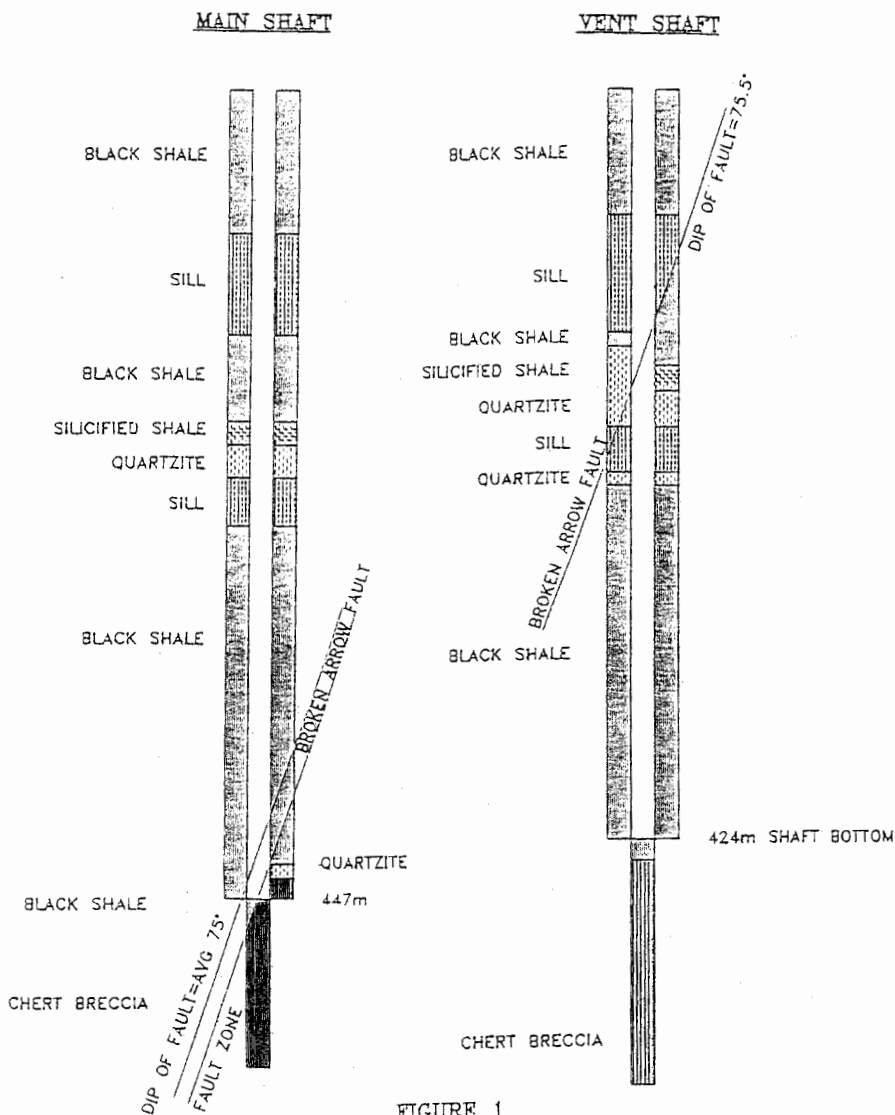
FIGURE 1

The shaft is so sited that it traverses the steeply dipping Broken Arrow fault at the intersection point of the giant chert breccia above the Malmani Dolomites of the Transvaal series. (See Figure 1 Shaft Elevations on 1 May 1996).

GEOLOGICAL SECTION SHOWING SHAFT ELEVATIONS ON THE 1st MAY 1996

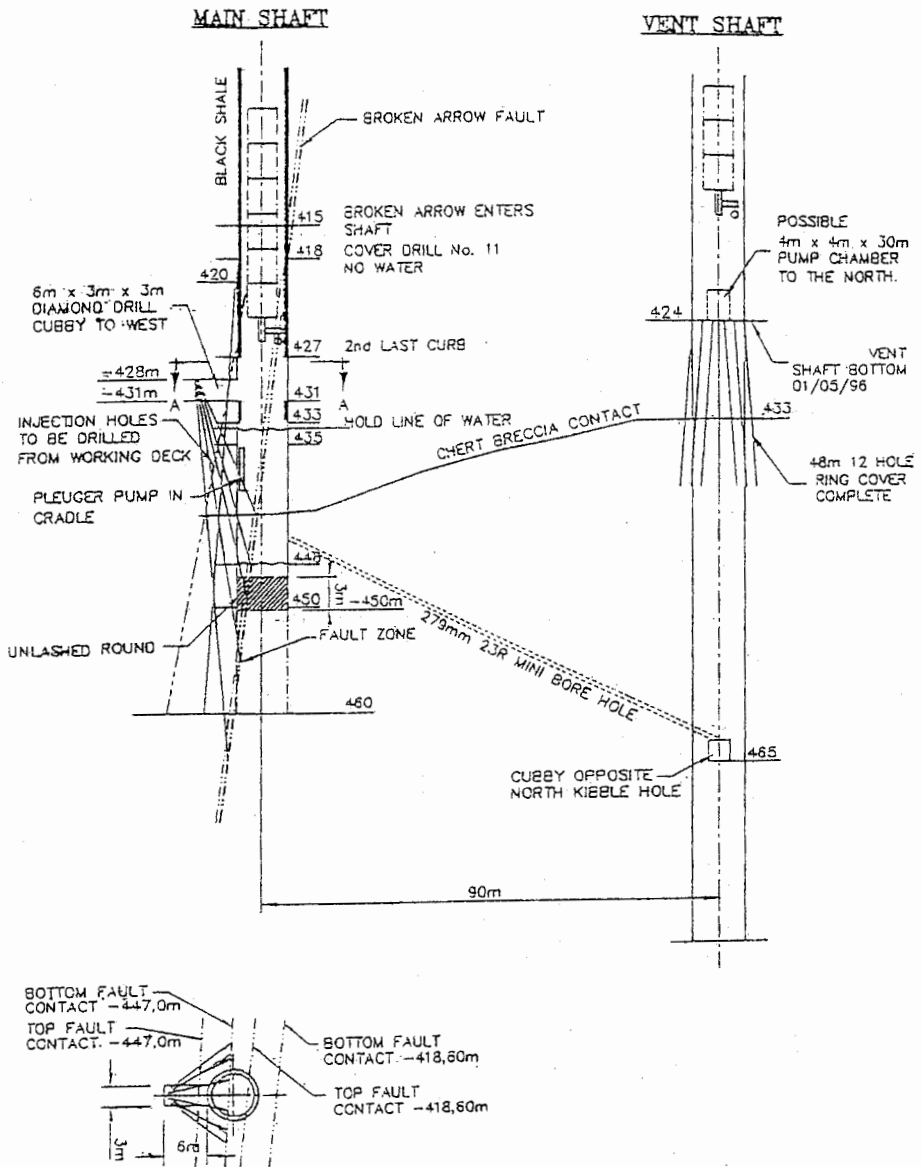
FIGURE 2

OPTIONS

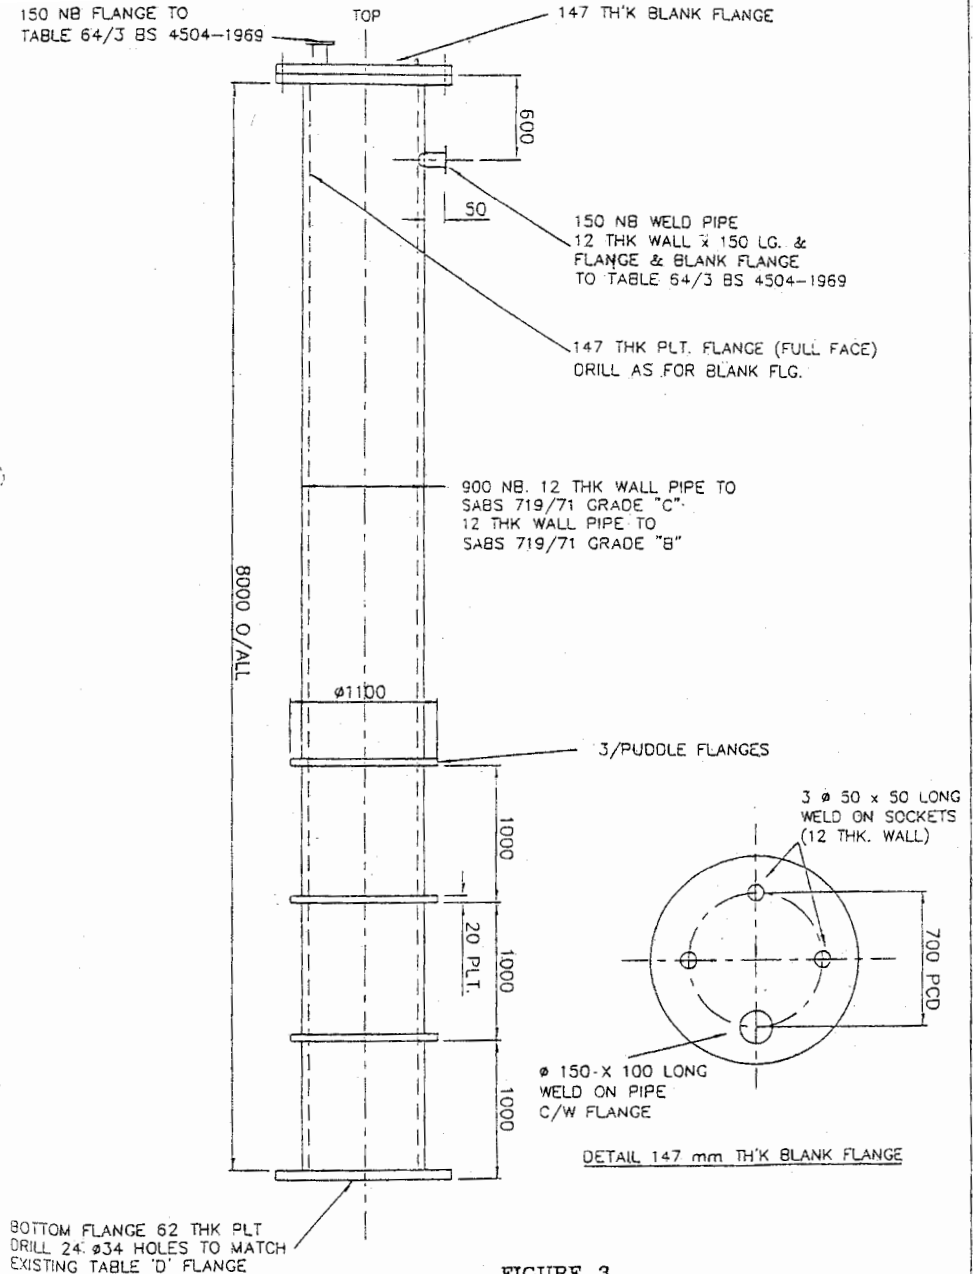
**FIGURE 3**

**900 mm PIPE WITH FLANGES AND PUDDLE FLANGES  
TOP DRAFT COLUMN**

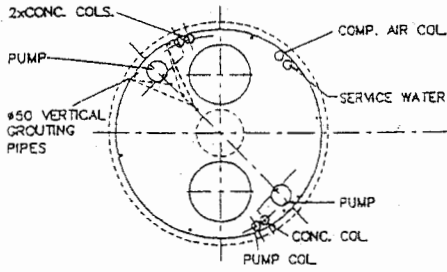
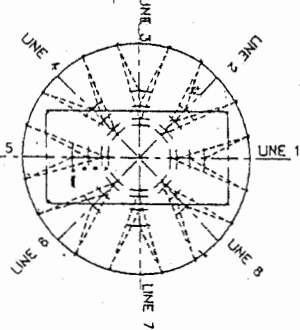
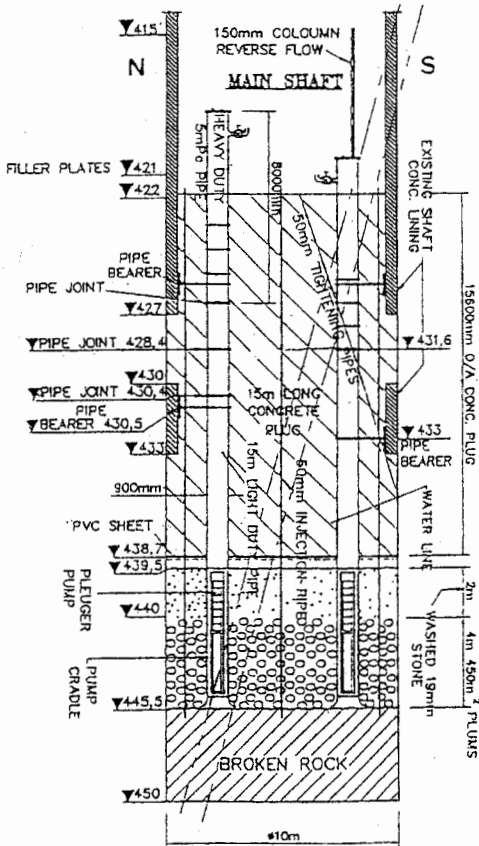
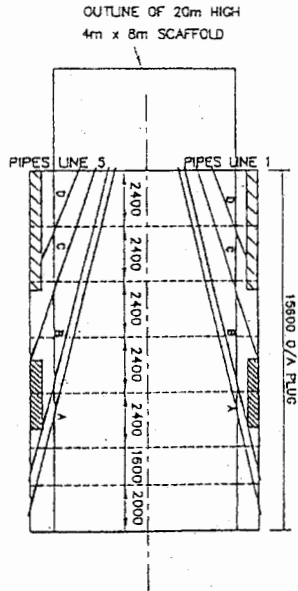
FIGURE 4

STRUCTURAL CONCRETE PLUG

This method entailed the constructing of a French drain and structural concrete plug, whilst continuing to pump with one submersible pump with another commissioned as a standby. A spare pump was kept on surface. (See Figure 4)

1. Install 2 x 900mm draft columns above the muck pile.
2. Install 7 x 50mm vertical Cementation injection pipes.
3. Tip 4m of washed plums on top of the muck pile.
4. Discharge two metres of washed 19mm stone down the concrete pipe on top of the plums.
5. Place PVC and geofabric sheets on top of the French drain above the water line.
6. Erect sacrificial scaffold and tightening pipes.
7. Cast 15 metre concrete plug.
8. Cure the plug.
9. Tighten the plug.
10. Remove pumps and blank flange draft columns.
11. Start reverse flow accompanied by cement grout intrusions.

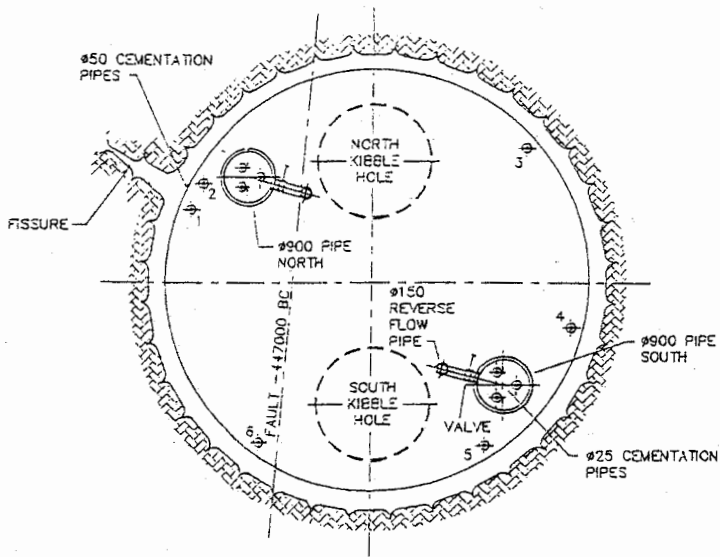
FIGURE 6

PLAN VIEW OF REVERSE FLOW PROCESS PIPES.

The reverse flow technique is the key to sealing exposed aquifers of this nature. Could the reverse flow and grout intrusion process have been made more efficient in terms of time? Supercharging the reverse flow process by increasing the feed pressure through a battery of pumps was considered, but the draft column pipes were limited to 7MPa and there were water supply quantity constraints.
