# SEALING OF HOT, HIGH PRESSURE WATER IN A DEEP UNDERGROUND GOLD MINE - A CASE STUDY

Peter L. Odell, J.P. Erasmus and C.A.C. Minie

Cementation Mining  
PO Box 59  
Carletonville, 2500, South Africa  
Phone: + 27 18 7816241, Fax: + 27 18 7811077  
e-mail: cemminbp@icon.co.za

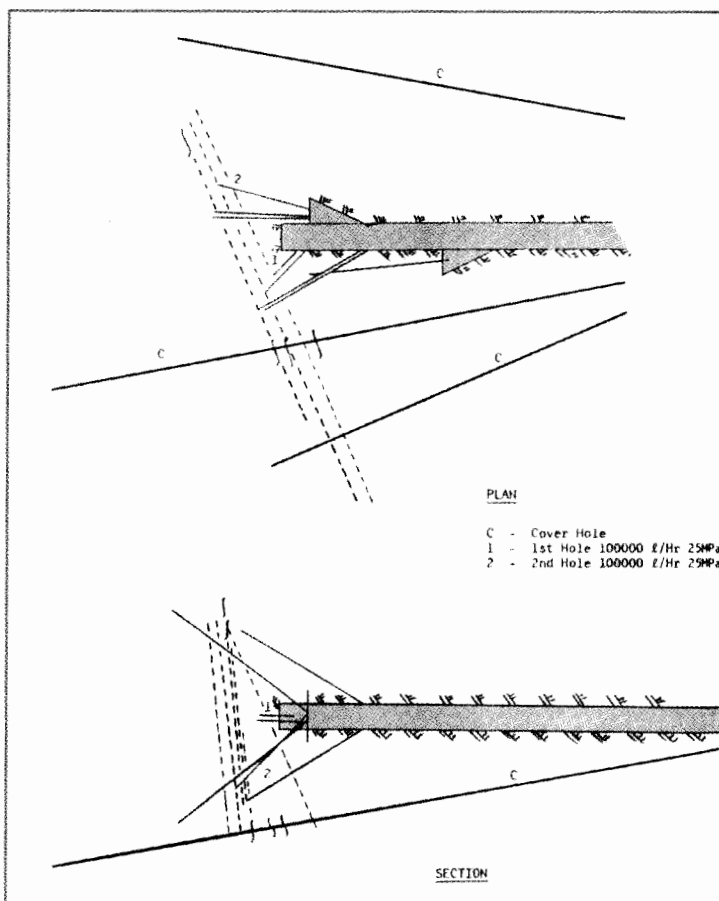
Figure 2. Plan and section of 41-56 HW Drive South showing all probe holes and fault zone

The development is in the hanging wall above the reefs in undisturbed quartzite of the Klipriviersberg Series with some known dykes and faults present. In fact the cover drilling revealed a faulted zone ahead of the advancing drive end. The cover holes are shown in plan and section in Figure 2. The previous two cover holes were dry, while the furthest produced 2500 l/hr which was not considered significant.

It was decided to call in the drilling crew to probe for water with a horizontal diamond drill hole from a position 3m back from the face 45° offline in the left-hand side sidewall. Normally forward drilling is done from a blasted cubby but in this instance, drilling was done from a sidewall position without the blasting of a cubby. As shown in Figure 2 the first hole advanced 4m, before it intersected water with potentially disastrous consequences.

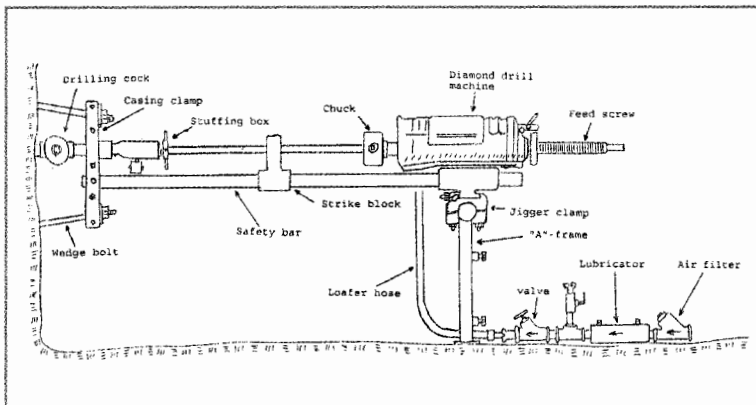
Figure 4. Diamond drill rig for normal conditions.

After the casing clamp, a stuffing box fitted with a 25mm high pressure valve was installed. A safety bar, strike block and chuck system with the machine mounted on the machine clamp all to the standard procedure was employed.

Because no high pressure, high volume water had previously been intersected on Kloof the single chuck system was standard at the time.

While probing for the source of water from this first hole, water was unexpectedly intersected less than 3m from the corner of the tunnel face. There was initially no indication that water had been intersected as the stuffing box was torqued up and the drill rods rear end was equipped with a core stopper. Upon loosening the chuck, the rods were pushed clear out of the hole and jammed in the machine's chuck.

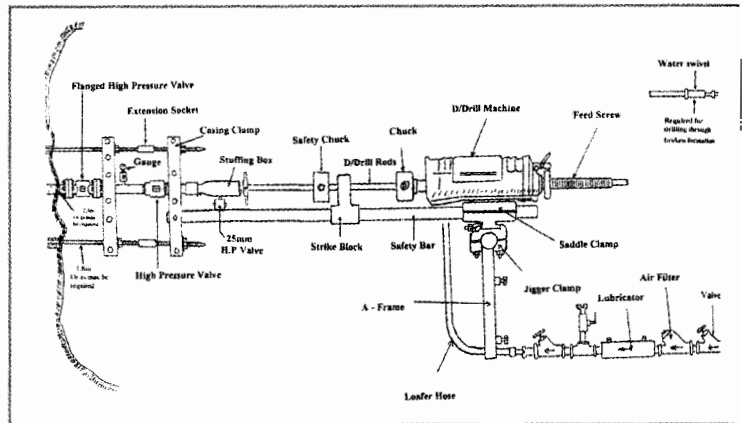
Figure 5. Diamond drill rig to cater for fissures under high pressure.

Following these incidents certain items composing the drilling set-up bean to fail. Threaded connections on the high pressure piping corroded through within one week of use.

- Water precaution safety equipment must be prechecked and tested.
- Double high pressure valves, double safety clamp and double supported safety bar to be employed in all cases where expected static head pressure exceeds 20MPa.

- Double chuck (safety chuck) system to be used on all cover and exploration holes in known water areas.
- After casing installation and setting time, redrill to rock contact and pressure test to 2x static head.

This led to the design of the system being reassessed and changed to stainless 316L flanged connections.

The modifications to the system are shown in Figure 5.
