Tailings Seepage Paths Mapped using Electric-Based Technology

Cecil Urlich¹, Andy Hughes², Val Gardner³

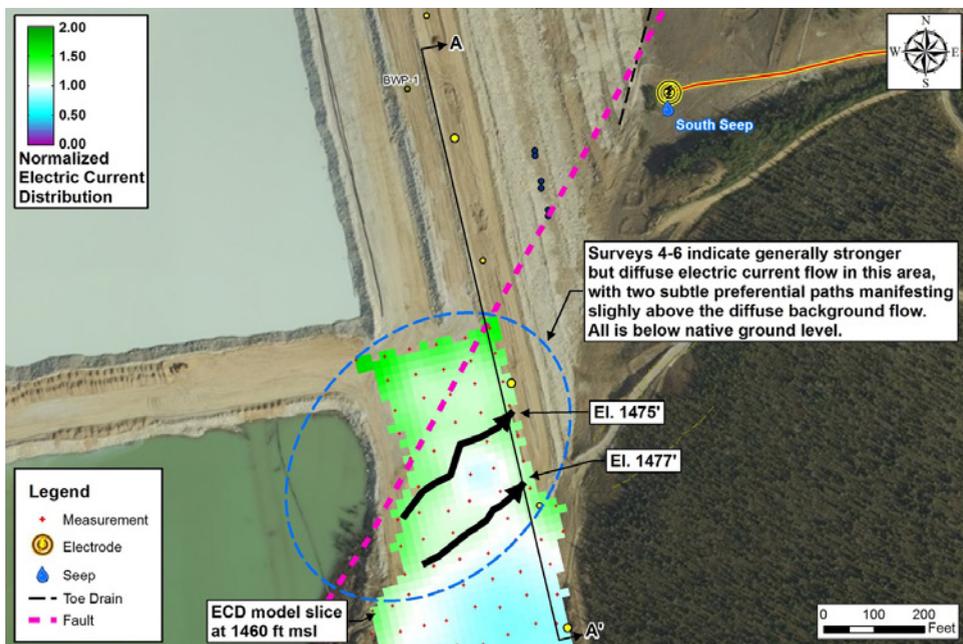
Figure 4 – Identified seepage paths shown in black with elevations posted at dam's crest.

No preferential seepage paths were identified in the left abutment area. The electric current through the area was observed to be uniform and evenly distributed in all three surveys. At the right abutment, the electric flow was observed to be more varied. Two seepage paths were observed in each of the three surveys, each providing confirmation of the next (Figure 4).

Both seepage paths were found to be located in the native foundation materials beneath the dam (Figure 5). In addition, both of these seepage paths followed the alignment of a fault that had been identified earlier by the mine.

No discrete seepage paths were observed between the TSF and the seepage that had been observed in the left abutment. All three of the south abutment surveys identified the same preferential flow paths in the foundation materials leading to the observed seepage.

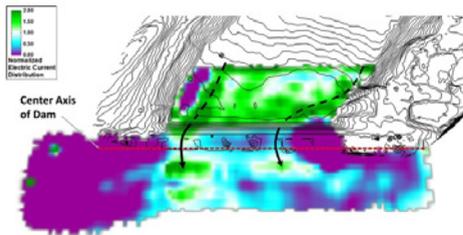
Figure 7 – Two seepage paths under dam

Survey 1 identified primary and secondary seepage paths under the dam (Figures 7 and 8). The plan and profile views show seepage path widths and depths. The green (medium gray) shading indicates seepage paths. The black lines are interpretations of seepage paths between the two electrodes.

The results confirmed that there are no other seepage paths of any significance through or under the dam. This provided confidence that piping and internal erosion were not concerns for the dam itself because the identified seepage paths are in the foundation materials under the dam and not in the dam structure itself. So the geotechnical investigations for piping potential could be focused on the foundation materials under the dam and not on the dam structure itself.

A geotechnical investigation was completed by drilling into the seepage path target areas identified by the survey. The drilling confirmed the survey findings. Remedial measures are now being planned that will be significantly less in cost than if the survey had not been completed and seepage paths not found because the investigation was targeted on the areas of concern.

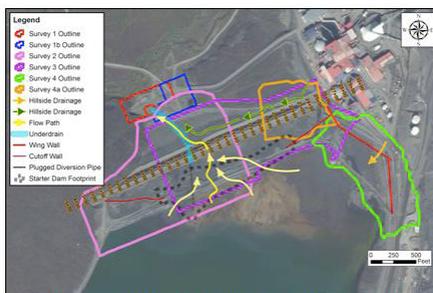
Figure S1 – Survey Coverage and Summary of Detected Seepage and Drainage Paths for Main Dam Area

During Phase 1, a seepage path was unexpectedly found into the TSF under the wing wall part of the tailings dam (Figure 10). The seepage path is broad at first but narrows down. This seepage path conveys drainage into the TSF from the east hillside under the wing wall 5 to 6 meters below the ground surface in what was confirmed to be a buried former drainage channel.

Seepage out of the TSF originates in original drainages under the TSF, converges to a rock under-drain in the original creek channel under the highest part of the dam, and flows through the underdrain to the seepage collection pond (Figure 10). The survey confirmed

that the TSF and seepage pond were performing as designed with no seepage out of the seepage pond.

A third drainage path unrelated to TSF seepage was identified. Originating from the right hillside just downstream of the dam, this drainage conveys water to under the dam's right mitre (Figure 10). Some of this water exits out from under the dam below the mitre. Some drainage mixes with seepage from the TSF. All seepage and drainage were found to be captured in the seepage pond.

No other seepage paths were identified through, under or around the tailings dam and seepage collection pond areas. The survey confirmed the design assumptions and performance expectations, and enabled planning to start for future tailings dam raisings and collection pond relocations to accommodate the increased footprint of an expanded tailings dam.

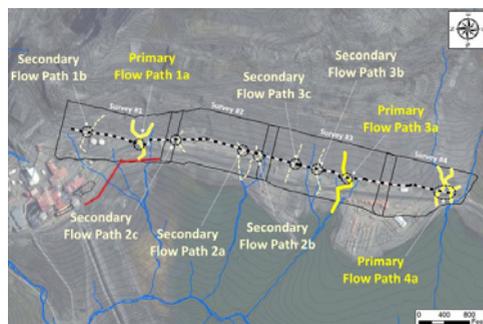
Figure 11 – Plan View of seepage paths

For the Phase 2 survey, solid lines are primary seepage paths. Light dash lines are secondary seepage paths. Dashed circles show electric current preferentially flowing through and under the trench. Primary seepage paths were found to align with original drainages (Figure 11). Secondary seepage paths are under the trench but are shallower than primary seepage paths.

The survey found that seepage from the waste rock dump was flowing under the dump along the drainage collection trench on the original ground surface. The model identified the depths of the primary seepage paths in the trench (Figure 11 and 12). Figure 13 shows the seepage paths.
