Evaluating the environmental impacts after the closure of mining activities, using Remote Sensing methods-The case study of Aliveri mine area.

Vasileiou E.¹, Stathopoulos N.¹, Stefouli M.², Charou E.³, Perrakis A.³

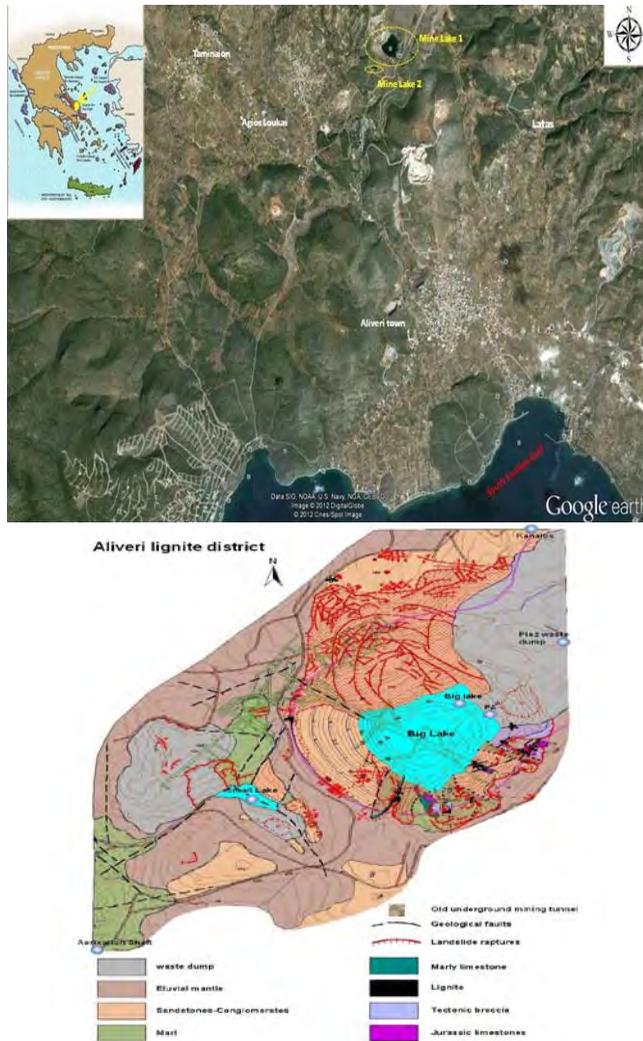
Figure 1 The wide area of Aliveri (left), the geological map of the lignite district of Aliveri (right)

In Evia island, located in central-east Greece, near Aliveri town, there has been a lignite deposit of about $26,5 \times 10^6$ tn (Figure 1). The surface of the study area is 110,32 km² and the average altitude about 264,5m. The exploitation started in 1951 using both, surface and underground mining techniques. The underground mining ended in 1980, while the surface activities continued until 1990. During the mining works, the dewatering procedure had to carry on, in order to keep the exploitation safe. The underground works developed in two different mines, Mine No 1 and Mine No 2. At the beginning, these two mines were not connected with each other, but later on, along with the progress of the works, they were connected through a number of tunnels (Minwater ECSC 2003).

In the wider area of Aliveri, the geological environment is consisted of limestones and loose neogene sediments. Above the neogene sediments lay the alluvial deposits (Figure 1). The mine waste deposits cover a wide area too (Dimitrakopoulos et.al. 2009).

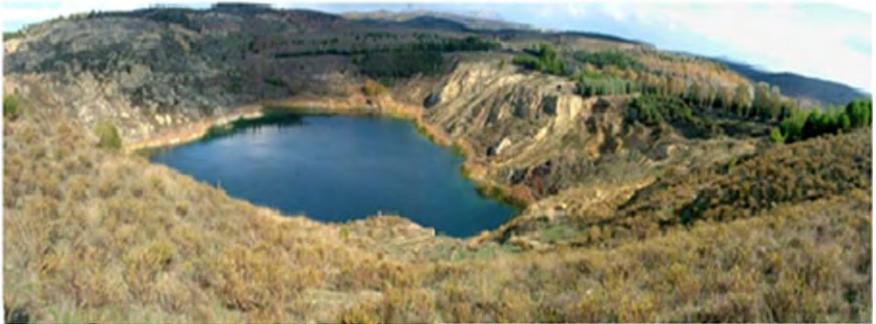
Figure 2 The “lake” in Aliveri area

Apart from the underground water systems, two surface water bodies (“Big Lake and Small Lake”) were developed in the residual voids of the surface exploitation. The ponds are recharged through the surface run-offs (Figure 2, 3). The mining works (underground and surface) created new and very complex hydrogeological and geomechanical conditions, which resulted in the appearance of cracks and huge gaps in the surface. These cracks, voids and gaps have formed new flow

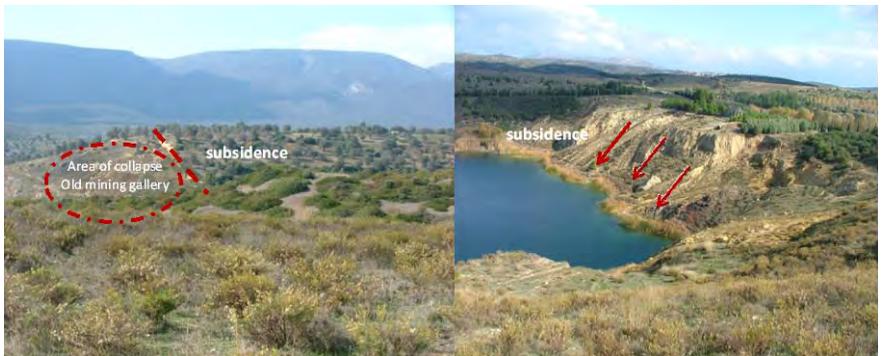
Figure 3 Southwestern slope of the lake, where failures were observed in the Neogene rocks (on the left). The western area of the lake (on the right), where subsidence depicted

patterns to the ground water. The aquifers have been connected in some areas and seawater – which was isolated by a clay layer – has now inrushed into the underground works. In the final voids of the open pit mine, small lakes have been formed. The lake was created after the completion of the surface lignite exploitation. In 1985 the level of the lake was at +35 m and in October 2002 at +60 m. The creation of remnant lakes seems to be an aesthetically acceptable solution, but it is not certain that this is also an ecologically stable one. Finally, failures of large extension appeared at the North Slope, which is not accessible (Figure 3) (Dimitrakopoulos et.al. 2009).

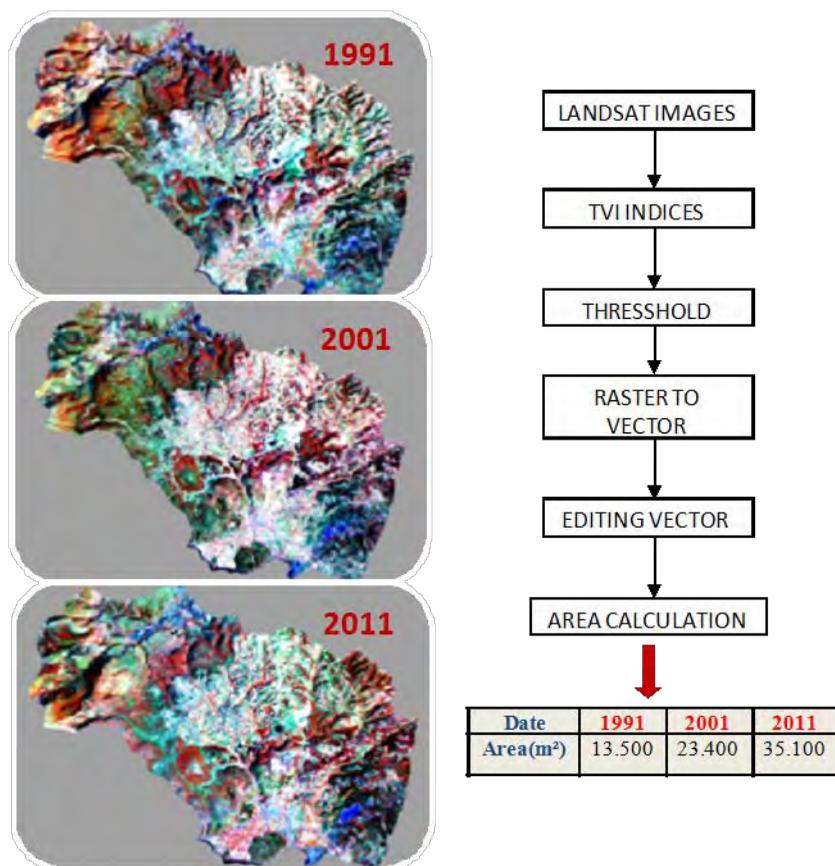
Figure 4 An RGB combination (R:TM4, G:TM5, B:TM3) for all images

The area of the lake was calculated based on thresholding the TVI images. The Transformed Vegetation Index (TVI), shows vegetation vigor computed from near-infrared and red spectral bands. The TVI formula takes the square root of the difference between the infrared and red values. If this difference is less than zero, the square root cannot be calculated for integer output. The raster image was converted to vector in order to capture the shore line and its changes through the years. (Unwanted polygons were manually excluded). An RGB combination (R:TM4, G:TM5, B:TM3) for all images is shown below (Figure 4).

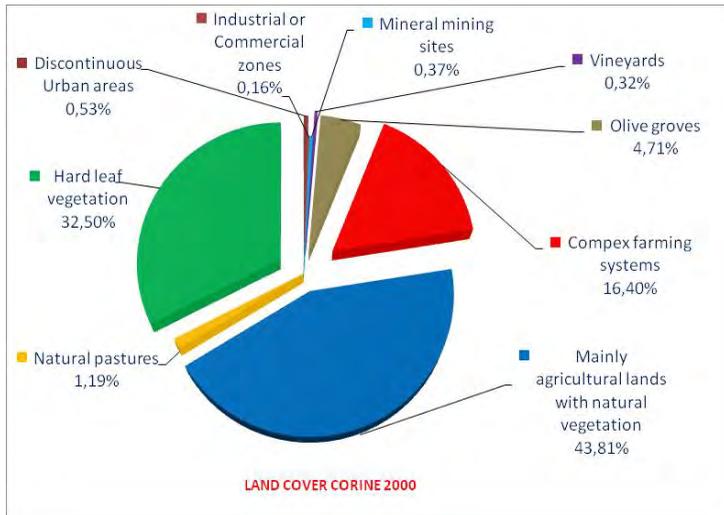
Figure 6 Statistical diagram of land use classification

As presented below (Figures 5,6) the Land Use of this area is mainly agricultural lands with vegetation, based on the Land Cover of Corine 2000. Farming covers a significant surface area and the mineral mining sites are very limited, which was expected as mining exploitation has finished. As described in the land use map, in the south east site of the basin there is quarrying activity.

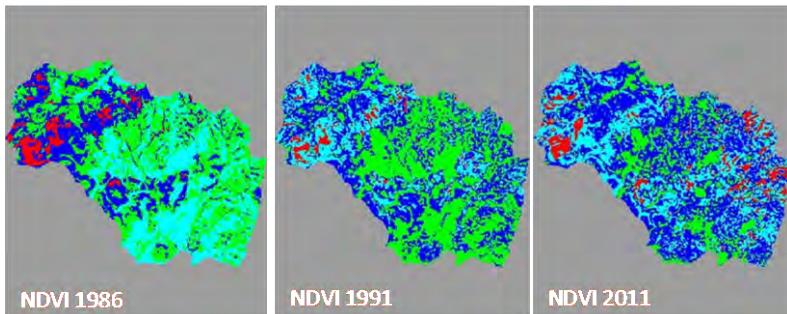
Figure 7 NDVI clustered values (Red: Very High , Green High, Light blue: Low and Blue: Very Low)

NDVI values indicate more green vegetation. NDVI for the Aliveri region and the years 1986, 1991, 2011 was calculated and clustered using a K-means clustering algorithm. For each year, four clusters were formed namely Very High, High, Low and Very Low NDVI values. The clustered NDVI values are presented (Figure 7) for Aliveri region for the years 1986, 1991, 2011. Although a direct comparison of the absolute NDVI values for these years is not possible, an increase of the percentage of Low and Very Low NDVI values (increase of abundance of Light Blue and Blue colors) is observed. This is an indication for the degradation of the vegetation which is in accordance to the land use /land cover changes interpretation (Figure 7).
