## **Environmental Risk Assessment and Risk Management Strategies for Abandoned New Union Gold Mine in Malamulele, Limpopo, South Africa**

**Abstract** Abandoned mines and mine tailings pose a hazard to communities that live around these sites. Here we report on the environmental risk assessment and risk management strategies of an abandoned New Union Gold Mine that is located in Ka-Madonsi village, Malamulele district, South Africa. The visual assessment was done through visits to the mine sites and the levels of heavy metals in the mine tailings soil and stream sediments was analysed with atomic absorption spectrometry. The hazards were then rated based on the probability of reoccurrence and the severity of the impact. The risk management strategies were suggested based on the severity and the probability of the impacts and the geographical setting of the area. The heavy metals: Cu, Co, Cd, As, Zn, Ni and Mn were found in the mine tailings soil and in the stream sediments. The mine tailings soils and stream sediments were acidic, within pH ranges of 3.93 to 4.45 and 4.18 to 6.28 respectively. The acidic soils can pose as a problem to the growth of plants and grass should they be

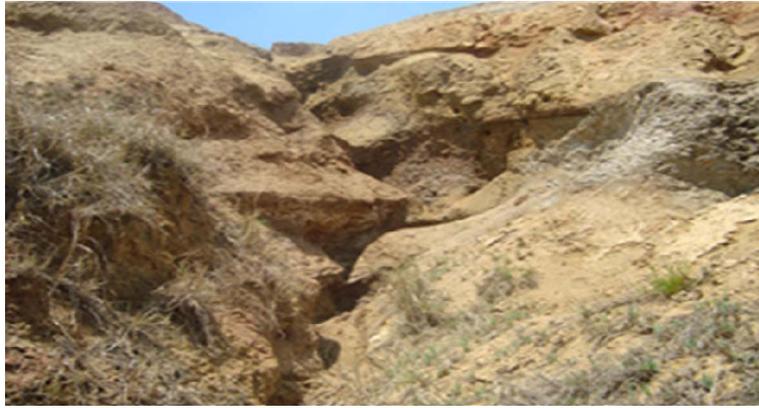
***Fig. 4*** Devastating effects of erosion in the tailings dump

The risks that were identified at New Union Mine are soil erosion, sedimentation, subsidence, open unsafe voids and shafts, vacant buildings and land scarification. Sedimentation was identified as one of the major problems due to water and wind erosion. Sedimentation refers to material or sediments that are carried from one area and are then applied up in another area. Sedimentation will also result in the destruction of habitat for aquatic species and thus disrupting the natural ecosystem. It will reduce the level of water in the streams and results in the deterioration of the water quality thereby posing a health risk for the people and animals drinking such water. Soil Erosion at New Union Mine is taking place at a very high rate at both tailings dump. This erosion is being influenced mainly by the slope angles and lack of any vegetation cover (fig. 4). The mobility of the tailings material to the environment is elevated by rainfall and wind actions. The severity of the erosion is high and the probability of the erosion occurring again is also high due to the rainwater and wind actions.

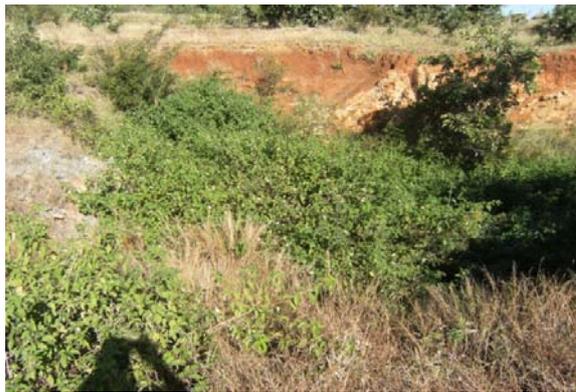
***Fig. 5*** (a) land subsidence; (b)unprotected or unfenced open shaft; (c)An open hole being used as a dump site and (d) derelict equipment littering the former New Union Minesite

The land subsidence was clearly visible at the mine site (fig. 5a). This may be caused by the collapse of underground mine tunnels since these are no longer supported internally (Xie and Liang 2010). Land subsidence is associated with the risk of surface structures such as houses cracking or failing into the ground this may result into people getting injured. In this area people reside next to this abandoned mine and chances of their houses subsiding into the ground increases every day when these voids remain opened. Children and animals are also at a greater risk of falling into these holes since the area is not fenced.
