Sinkhole development on mine flooding

Gareth Digges La Touche¹, Barry Balding², Brian Keenan², Susan Digges La Touche³

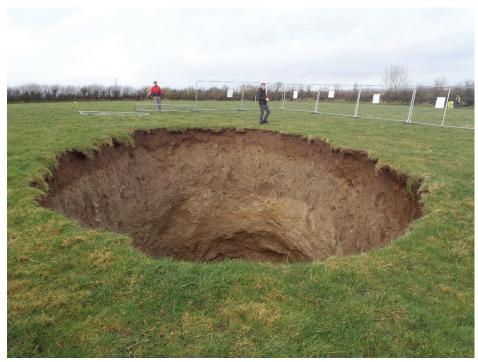
Figure 1 Sinkhole a few days after development.

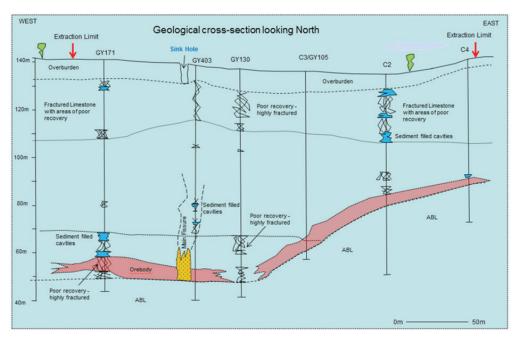
Figure 2 Relationship between the mine workings and the sinkhole.

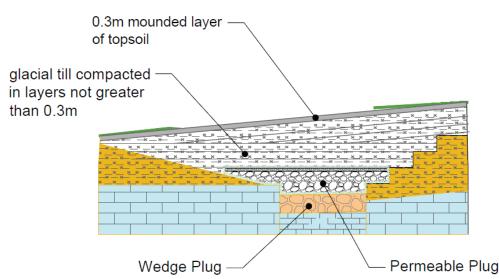
Figure 4 Implemented approach to sinkhole remediation.

To remediate the sinkhole and allow the return of the field to agricultural use, a permeable plug was recommended to conserve the drainage pathway and to help alleviate the formation of further sinkholes in the vicinity. This was achieved (Figure 4) through the use of a simple bridging mechanism (≈ 1 m diameter boulders), over the throats between the limestone pinnacles which were exposed through excavation; the lower section comprising a permeable rip rap and ballast plug encapsulated in a geotextile. The upper section of repair entails compacted layers of rock fill/glacial till and a final capping layer of appropriate subsoil and topsoil to rehabilitate the agricultural surface.
