The Macraes Gold Mine Irrigation Project, New Zealand

Abstract

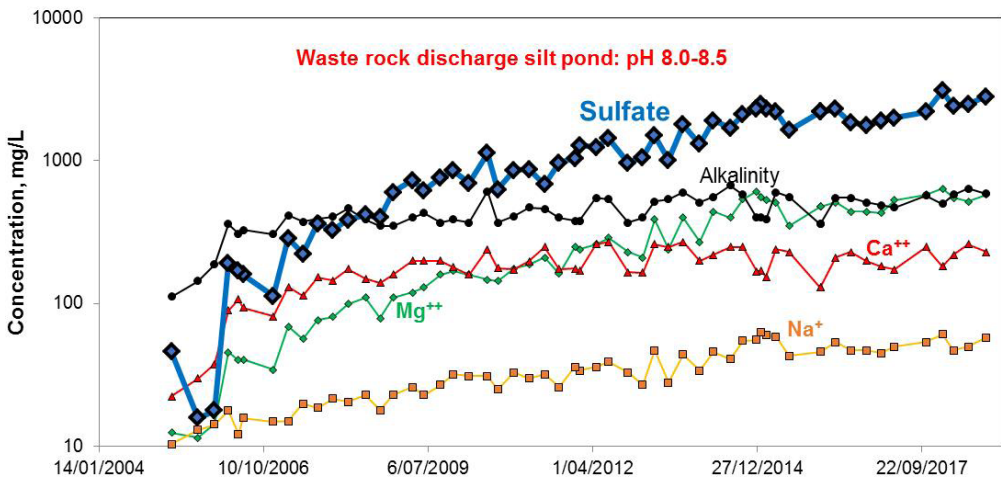
Figure 2 Evolution of waste rock water compositions over time, as measured by routine environmental monitoring at the silt pond below a waste rock stack (Fig. 1b; bottom). Modified from Weightman et al. (2020); alkalinity is presented as HCO_3^- .

The waters are neutral-alkaline (pH 7.5-8.5) with high alkalinity, Ca and Mg, as well as high sulfate (Fig. 2,3). The waste rock water compositions have evolved rapidly with time to become progressively more concentrated (Fig. 2), and the waste rock & tailings seep

waters have broadly similar compositions although Na contents are generally higher (300 mg/L) and pH is lower for the latter (Fig. 1b). The elevated sulfate concentrations arise because of oxidation of pyrite in the waste rocks and ore, and abundant calcite in these rocks ensures that any acidification is neutralised, with substantial increase in alkalinity (Fig. 2).

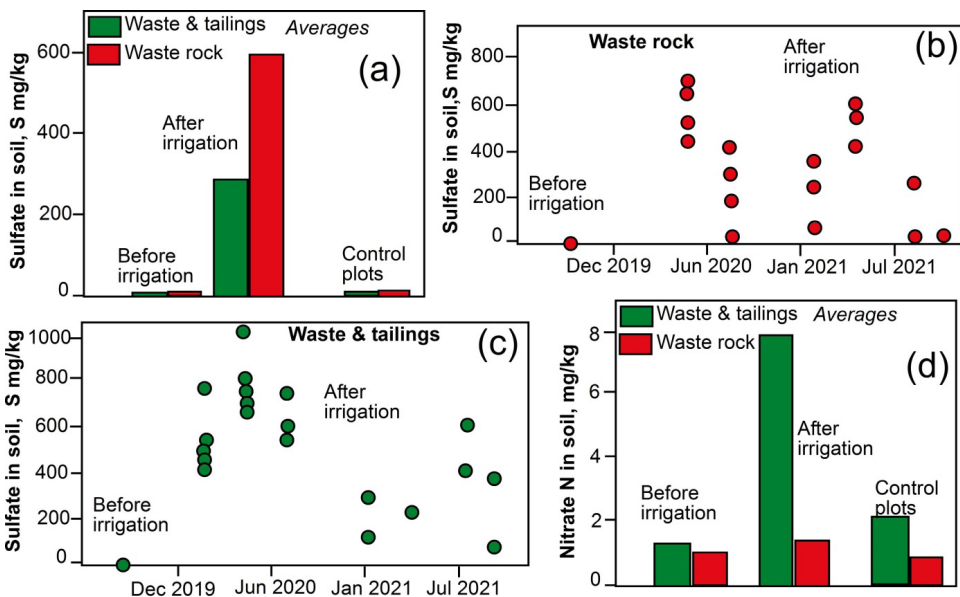
Figure 4 Soil chemical data for the two water types irrigated via agricultural sprinklers on to pasture over a 22 month period. (a) Average sulfate S before and after irrigation, compared to nearby control plots. (b) and (c) Sulfate S contents over time, showing declines after summer (Dec-Feb) irrigation periods. (d) Average soil nitrate N before and after irrigation, compared to nearby control plots.

Results showed no observed adverse effects on plants from sprinkler irrigation at the waste & tailings Site 2, nutrient contents of soil increased (Fig. 4a,d) and grass pasture species flourished in growth and biomass (Fig. 5). At Site 1 waste rock silt pond irrigation, most pasture responded well to irrigation compared to control plots, and nutrients increased (Fig. 4a,b,d) but some water pooling during irrigation caused localised (square metre scale) pasture die back in late summer (Fig. 6). Ongoing observations at these die-back spots showed foliage and soil surfaces covered in Ca-carbonate and iron precipitates as thin surface crusts. These minerals lasted through winter but became progressively less abundant. By the end of the trial, they had broken down and normal pasture regrowth was observed to be resuming.

Soil sulfate S and nitrate N contents increased substantially during the irrigation trials, although these nutrients decreased over time after irrigation ceased (Fig. 4a-d). The higher levels of S and N in the irrigated soils were typical of well-fertilised agricultural pasture. Herbage S levels slightly exceeded typical agricultural values but N levels did not.

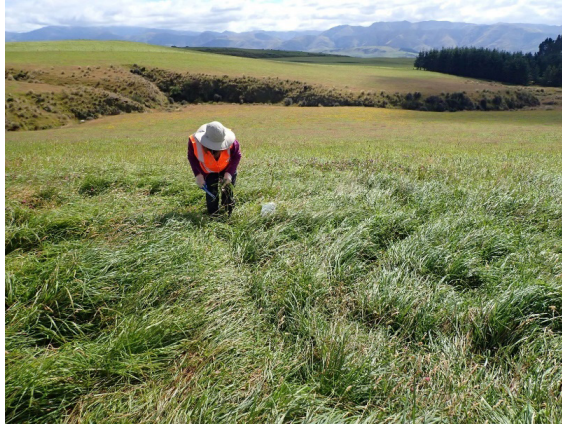
Figure 5 Abundant summer pasture growth in irrigated Site 2 below the waste & tailings seep site.

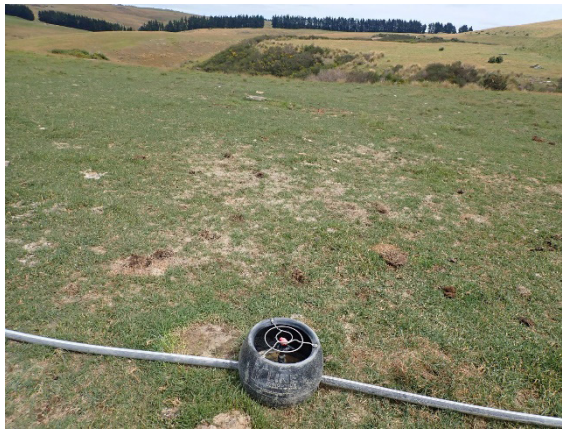
Figure 6 Summer pasture growth at Site 1 irrigated from the waste rock silt pond. Pale patches near the irrigation sprinkler developed from water ponding and Ca-carbonate and Fe oxyhydroxide precipitation on plant and soil surfaces. These mineral deposits waned over the following winter, and pasture re-grew in affected spots.
