Abandoned Coal Mine Mitigation in Artesian Conditions

Joshua Zimmermann

Brierley Associates, Cottage Grove, MN, USA, jzimmermann@brierleyassociates.com

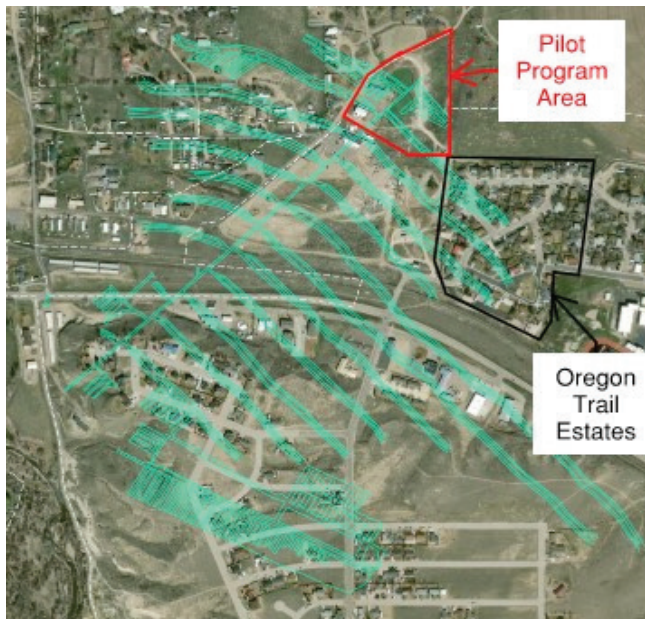
Figure 1 Mine Map of Glenrock No. 1 and No. 2 Mines

Glenrock, WY is a town of 2,400 people in central Wyoming, approximately 25 miles (40 km) east of Casper, WY. The Deer Creek Coal Company began regular underground coal mining operations at the Glenrock No. 1 Mine on October 1, 1888 (Day, 1890). By the end of 1891 the main stope had been driven down dip for 1600 ft (500 m) with the coal seam averaging 6.5 ft (2 m) thick (Johnson, 1892). By the end of 1907, the main stope of the No. 1 Mine extended for 3000 ft (900 m) down dip while the No. 2 mine extended for 1200 ft (365 m) nearly on strike of the coal seam, with both mines being operated essentially as one (Shaw 1907). The No. 1 Mine extended north almost as far as the Platte River, and being approximately 200 ft (60 m) lower than the river at this point, it required continuous pumping for dewatering. Owing to a poor roof, large amounts of water in the mine, and the inability to utilize the coal as fuel for the local railroad, the mine(s) were permanently closed in late 1909. A mine map for the Glenrock No. 1 and No. 2 Mines is shown in Fig. 1.

The pilot program was conducted just northwest of the Oregon Trail Estates (as shown in Fig. 1), which was an area subject to similar hydrogeologic, geochemical, and geotechnical conditions. This undeveloped property was generally flat, containing minimal topographic relief. Because of the existing water-filled gravel pit (pond), this was an ideal location to conduct this pilot study to allow mine water discharge and provided ample space to allow for any adverse variability in water control issues. The area of the pond measured 43,000 ft² (4,000 m²) and is shown in Fig. 2. With 2 ft (60 cm) of available freeboard, this provided roughly 630,000 gallons (2.4×10^6 L) of available storage for groundwater discharge within the mine interval, not including evapotranspiration rates.

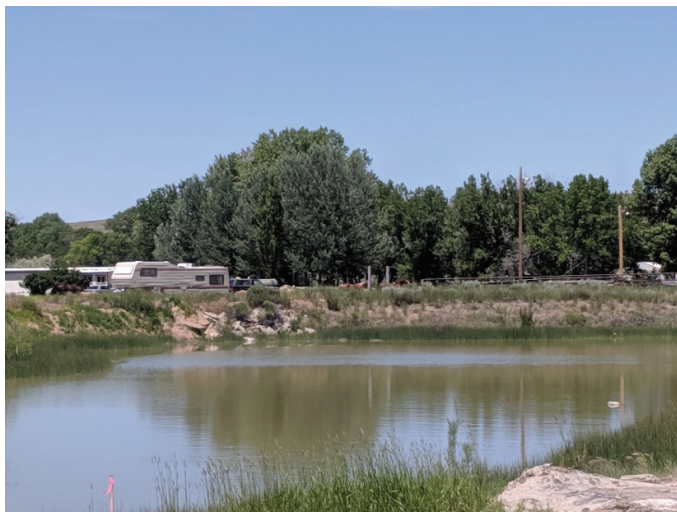
Figure 2 Pond Adjacent to the Pilot Program Site for Discharging Mine Water

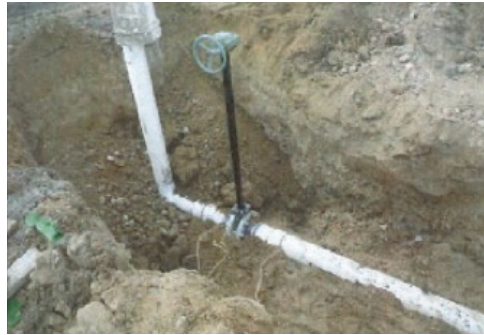
Figure 3 Discharge Well Setup for the Pilot Mitigation Program. The Valve Seen in the Figure Allowed for the Controlled Release of Artesian Groundwater at Various Rates

Two discharge wells were also installed for the pilot program (as shown in Fig. 3). Each discharge well consisted of a 5 in (12.7 cm) diameter PVC pipe drilled into the void of the mined interval so that artesian water would flow to the surface. No pumping equipment was needed nor installed on either discharge well. Sealing within the annular spacing of the PVC pipe consisted of K-Packers and bentonite chips to the surface. A pressure-sealed adaptor was installed 1.5 ft (0.5 m) below grade and fitted with a control flow valve to divert water through a perpendicular 12.7 cm PVC to the storage pond. Diversion casing was also set below grade at 1.5 ft (0.5 m). Artesian water flow rates remained consistent throughout the project through the discharge wells, with a maximum rate of up to 400 gpm (1.5m³/min). A diaphragm pressure gauge (maximum measuring capacity of 100 PSI or 700 KPa) was added as a secondary monitoring source for quick pressure observation in the field.
