Tailings Seepage Paths Mapped using Electric-Based Technology

Cecil Urlich¹, Andy Hughes², Val Gardner³

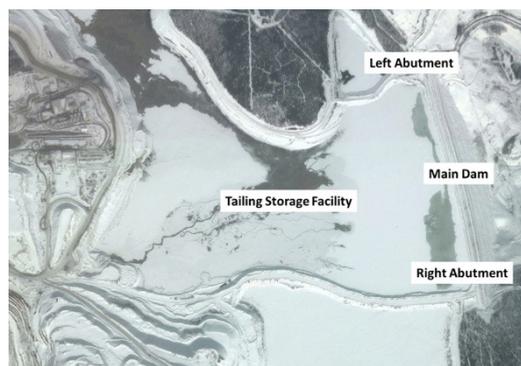
Figure 3 – Valley fill tailings storage facility and dam.

Tailings Dam Study 1 involves a TSF where seepage was suspected in left and right abutments (Figure 3). A dike separates the cells. A settling pond and open pit are near the new dam.

Seepage had been observed at both right and left abutments of the main dam. The seepage flow was not excessive and there was no sign of turbidity. However, the mine decided to investigate further using the electrical-based technology due to its non-intrusive nature and ability to identify the full seepage pathway in plan and elevation.

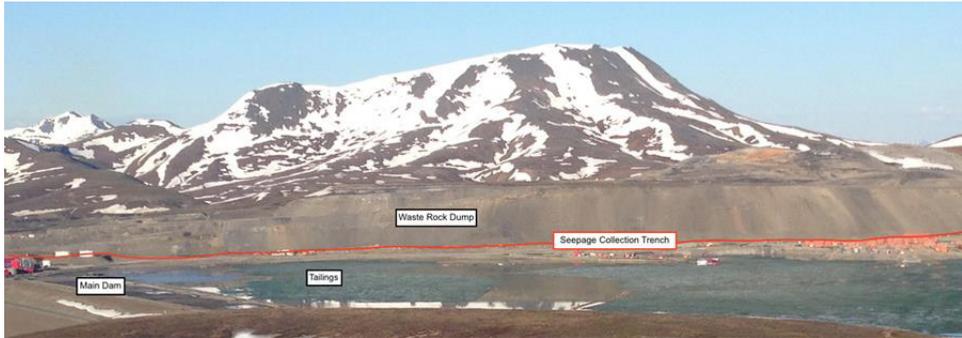
Figure 9 – Tailings facility and waste rock dump

Tailings Dam Study 3 involves a TSF with a tailings dam in a valley. A seepage collection pond is downstream of the tailings dam. A waste rock dump occupies one of the valley sides of the TSF. A 2-kilometer long drainage collection trench is aligned along the toe of this dump (Figure 9).

Seepage from the TSF collects in a collection system and is pumped back to the TSF. Additional contribution to the pumped back water is surface runoff from the collection system catchment area. There was concern that some “surface runoff” could also be seepage from the TSF through the left abutment of the tailings dam, and that there could be seepage from the TSF flowing under the collection system and to the environment.
