VACUUM DRAINAGE TO STABILIZE ROCK SLOPES ON MINING PROJECTS

Brawner, C.O. and Pakalnis, R.

University of British Columbia, Vancouver, Canada

ABSTRACT

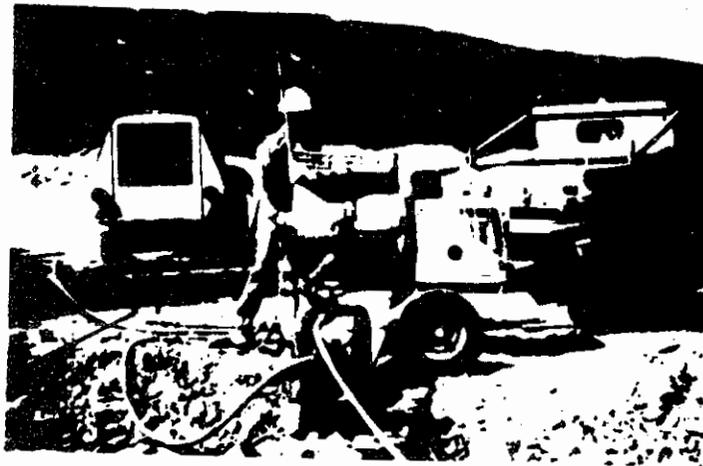
Fig.11 Photograph of Grout Unit

was composed of a blank section of PVC pipe which was enveloped by a cement grout. It is desirable that an expansive cement be employed, ie 10% enderblast-N. The packer was inflated by means of a nitrogen canister which requires approximately 3 l/hole of gas. The entire drain, including perforation, packer and grout sections were inserted pre-fabricated into the drainhole. It was found that a bentonite surface pack aided the development of a more complete seal. (Fig 10) The grout unit consisted of a grout pump and mix tank as shown in Fig 11. Cement was pumped into the collar of the drainhole and air was exhausted from a tube terminating at the junction between the packer and grout section.
